Lifter Noise

December 2021 - Volume 48, Issue 10

Corvair Year One (AKA the Era of Leaks)

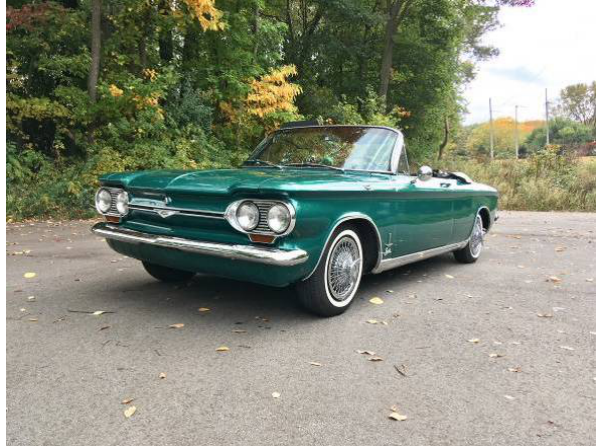
First Picture of the Corvair

In any case the Corvair was generally in very good condition with the only obvious issue at the time being a minor drip coming from the lower engine shrouds. In my great wisdom I batted no eye at this, knowing from my previous year of research that the infamous pushrod o-ring leaks were as common as (expletive) Nader bumper stickers. The previous owner even had the foresight to order the right o-ring kit from Clark's in advance, a bonus with purchase. In any case the deed was done and I happily drove 4.5 hours home from the Cleveland suburbs with virtually no interruption, save for the questionable choice of stopping at a central Ohio Big Boy for dinner.

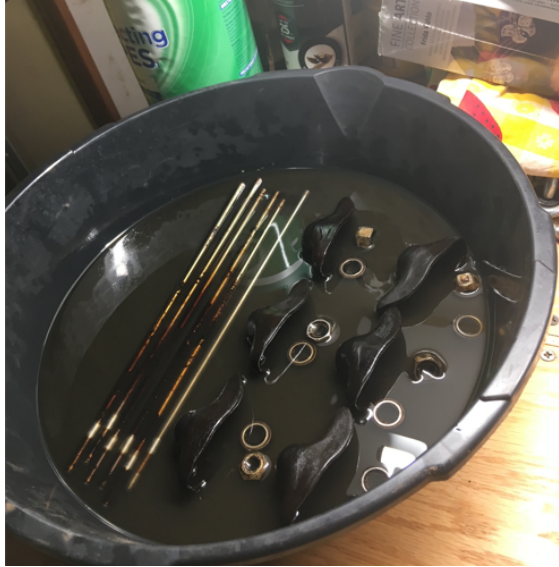
Cleaning Components

So March comes along and I set to work on the pushrod tube o-rings. I pulled off the lower shrouds and spent the first couple nights degreasing through layers of caked-on oil residue until I could better make out the head casting surface. Then I pulled the valve covers, loosened the rockers and pulled all the pushrods out in careful order to keep things as they should be. I soaked all the components in gasoline to cut the crud and got to work on the pushrod tubes.

It was clear the original o-rings had turned to glass so I felt pretty good about the track I was on. After cleaning everything up I installed the new o-rings, coated everything with oil and re-torqued the heads per the shop manual. I had also ordered a set of rear differential axle half-shaft seals, so I took the time to replace these as well. I was pretty happy that this could be done with relative ease while it was still in the car. I think I must have had a pretty nice day sometime after that since I idled it out of the garage and proceeded with the running lifter adjustment in the driveway. As I am sure my neighbors enjoyed it took me about an hour of idling with the exhaust off before I got the hang of it. I realized that sometimes as you loosen the rocker nut the pushrod can fall out of the detent in the lifter or rocker and give you a false sense of tightness. So you really need to make sure the pushrod is seated as you feel for clatter. This is made all the more special as the motor spits hot oil and backfires six inches from your face.

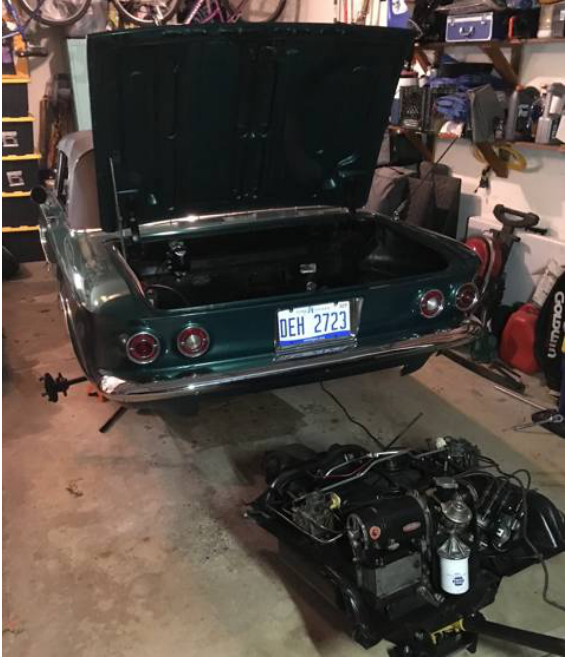
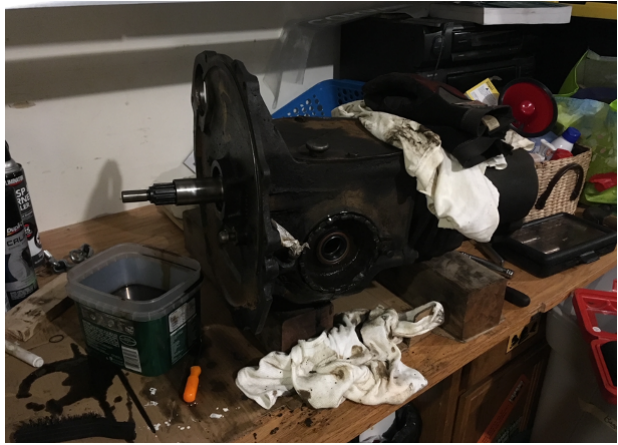
Separation Complete	Transmission+Axle Seal Replacement

Lucky for me I realized that pulling the Corvair powertrain was ludicrously easy. One night of carefully disconnecting linkages and documenting, then a second for placing the transmission jack and lo and behold there's now a motor occupying the spare half of my garage. Cracking open the clutch bellhousing at this point was also quite straightforward, then I carried the

tranny+axle over to my workbench and set to work on seal replacements. I replaced the transmission input shaft seal and also unscrewed the axle side flanges and replaced the large o-rings as well. Just for good measure I also put new axle half-shaft seals in again, why not. Maybe I didn't get them in square the first time. As I started to put the transmission back together I spent a little while inspecting the clutch and the inner walls of the bellhousing. I decided after some deliberation that the crank side seal and the rest of the surfaces looked clean enough so I had likely solved the pesky leakage issue. Famous last words.

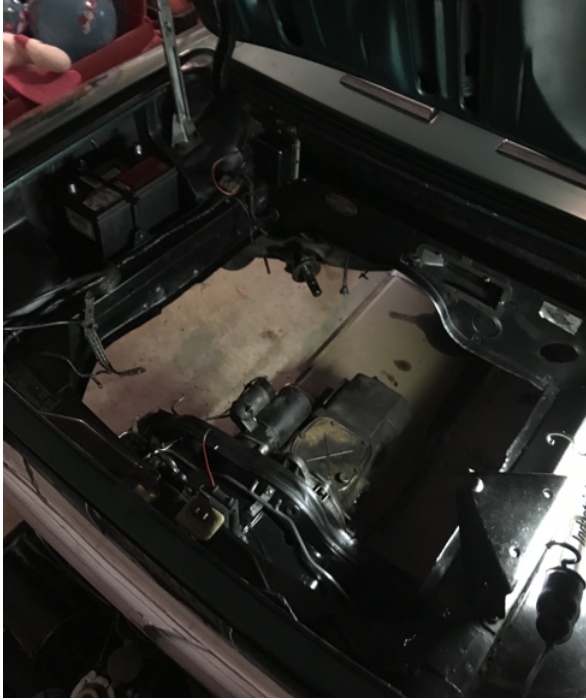
One More Time

So the second time it really went quick. I had the motor on the ground in no time flat and soon thereafter the clutch plate was on the ground and I was carefully loosening the bellhousing from the crankcase. Lucky to have the support of Clark's again the seal kit was shipped promptly and contained everything a leaky Corvair needed. The crank output seal was shockingly brittle, almost felt like aluminum as I pried it out. Now I knew I had really found the culprit. I got the

clutch plate all put back without incident and before I assembled the tranny for the second time I went and replaced that input seal again just because and set it all back in place.

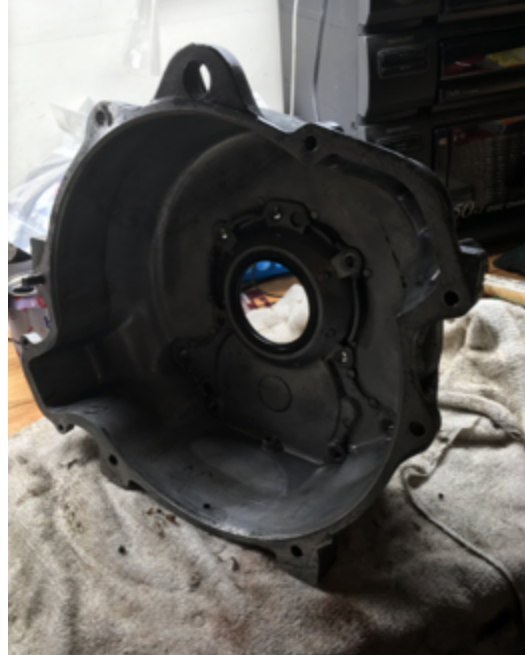
The Culprit...
